### A Case Study on Usage of Electrical Resistivity Tomography for Dam Seepage Location, Chesterfield, Missouri

Four Electrical Resistivity Tomography (ERT) profiles and borehole data were acquired on the front face of the earth-filled dam and on the flanks, constituting Lake #1, in order to locate the seepage zone, the flow path, and to determine possible reasons of the seepage. The seepage, observed a year after the construction in the southwestern part of the lake, was severe and could cause further softening, slippage and erosion of soil, developing of pipe holes, increasing the water outflow and risk to the embankment integrity. The owner agreed to drain the lake in order to acquire geophysical and borehole data. Based on the analyses of the acquired ERT and borehole data, four solution-widened fracture zones trending from southwest to northeast were identified. It was concluded that the seepage pathway beneath the dam was through a solution-widened fracture zone, the top of which constituted the original stream channel.

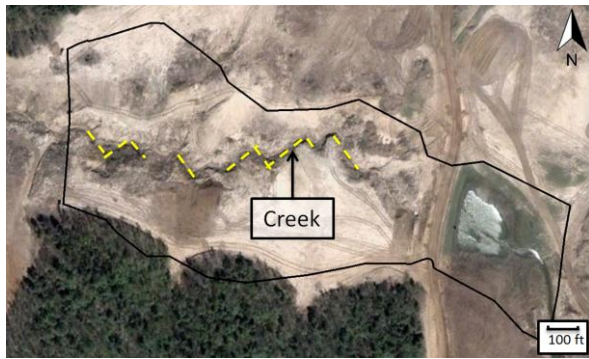
**Figure 2.** Aerial image of the study site prior to the lake construction. The dam was constructed in the valley with a creek. Black outline shows the lake area, constructed later. Yellow dashed line shows the stream flow, following the joints sets orientation in the study area

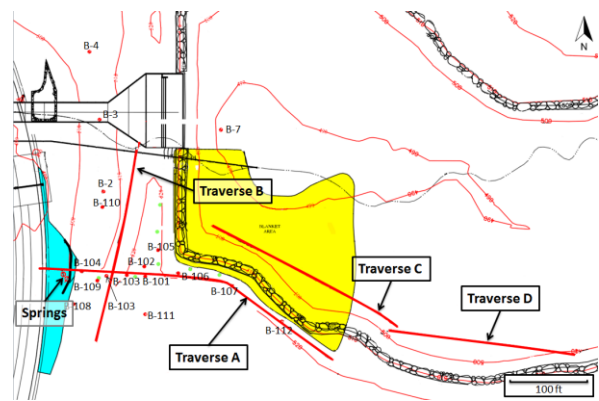
**Borehole data.** Total nineteen boreholes were drilled at the study site. Boreholes B-104, B-103, B-101, B-1, B-102, B-106, B-107, B-112 were located near or on Traverse A (Figure 5). Boreholes B-101, B-106, B-107, B-112 were located approximately at the elevation of 520 ft, at the same elevation as the crest of the dam. Weathered bedrock and fragments of chert were encountered in these boreholes at the depth of 28.5 ft to 40.5 ft. The variation in the depth to bedrock might be explained by the fact that the lake was constructed in the old stream channel valley and the boreholes were located south from the original channel.

**Figure 5.** Map showing location of ERT traverses and boreholes

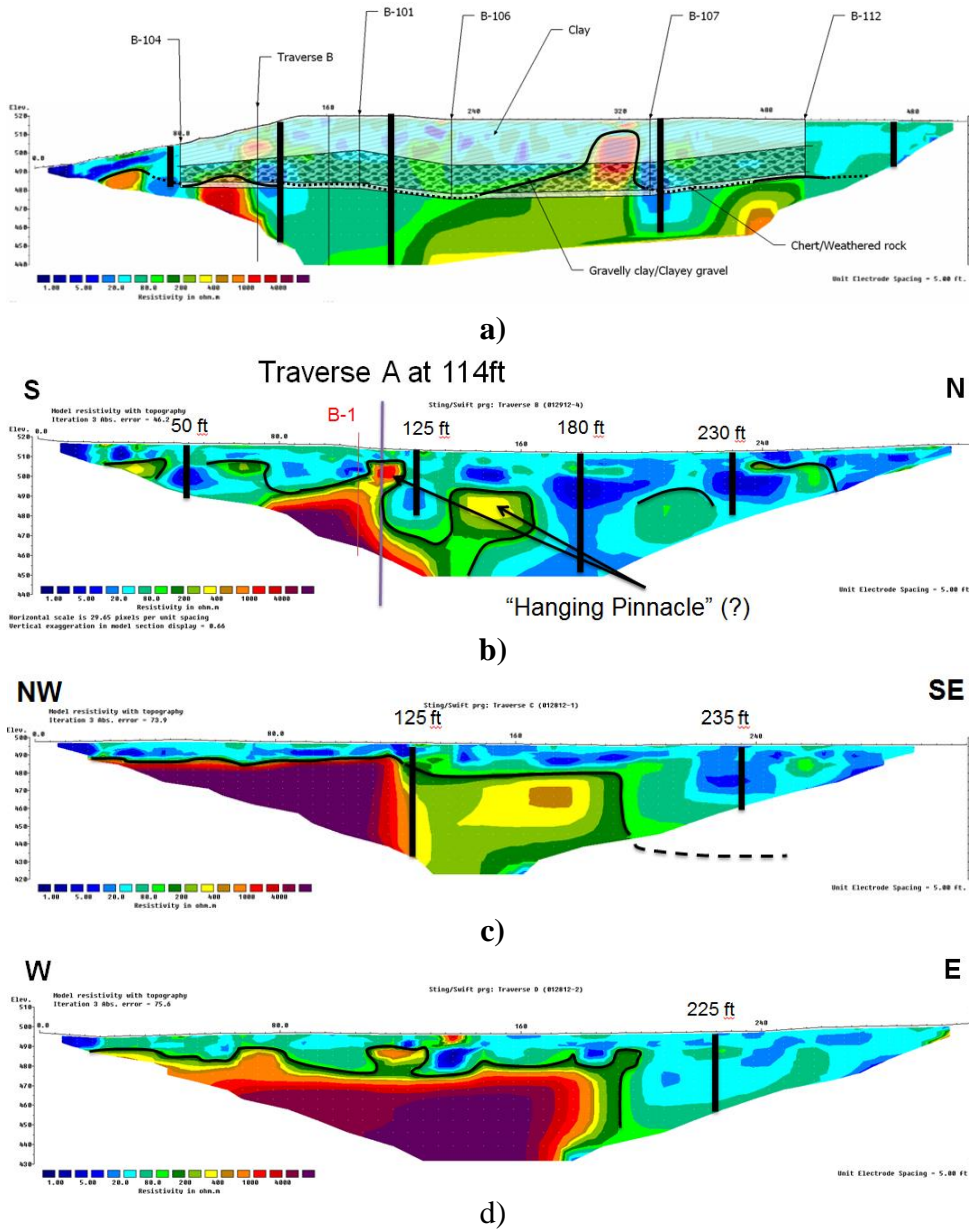
The first set of solution-widened joint trends southwest-northeast and was imaged on resistivity Profile A (centered at 70 ft mark; Figure 7a) and resistivity Profile B (centered at 180 ft mark; Figure 7b). This prominent geologic feature, on Profile A, is characterized by a zone (~30 ft wide, extending from top of rock to depths in excess of 20 ft) of anomalously low resistivity values (relative to surrounding resistivity at comparable depths on the same profile and other profiles). This zone of anomalously low bedrock resistivity was interpreted as an area in which rock has been extensively leached and partially replaced by clay or other fine-grained sediment. The same feature, on profile B, is characterized by a zone (~35 ft wide, from top of rock to depths in excess of 20 ft) of low resistivity (relative to surrounding resistivity at comparable depths on the same profile and other profiles).

The fourth set of solution-widened joints trends southwest-northeast and was imaged on resistivity Profile A (centered at 460 ft mark; Figure 7a) and resistivity Profile C (centered at 235 ft mark; Figure 7c). This prominent geologic feature, on Profile A, is characterized by a wide zone (~70 ft wide, extending from top of rock to depths in excess of 30 ft) of anomalously low resistivity values (relative to surrounding resistivity at comparable depths on the same profile and other profiles). This zone of anomalously low bedrock resistivity was interpreted as a possible area in which rock has been extensively leached and partially replaced by clay or other fine-grained sediment. The same feature, on Profile C, is characterized by a zone (~40 ft wide, from top of rock to depths in excess of 40 ft) of low resistivity (relative to surrounding resistivity at comparable depths on

A solution-widened fracture zone mapped on profile D at 225-ft mark (Figure 7d) appears to be wide (over 40 ft) that may be caused by the orientation of this zone. Most

likely, this zone is oriented north-west at oblique angle relative to a profile line; however, the orientation cannot be determined confidently due to lack of data. All four mapped lineaments were superposed on a photograph (Figure 8) and a map of faults and structural lineaments in Missouri (Figure 9).

**Figure 7.** Interpreted ERT Profiles: a) Profile A with superposed borehole cross-section; b) Profile B; c) Profile C; d) Profile D. Black contour line represents depths to interpreted bedrock (dashed black line represents estimated depth to bedrock). Interpreted solution widened joints are marked as black vertical lines

ies and mapped faults and lineaments in the study area. It was concluded that the seepage pathway beneath the dam was through a trending southwest-northeast solution-widened fracture zone.

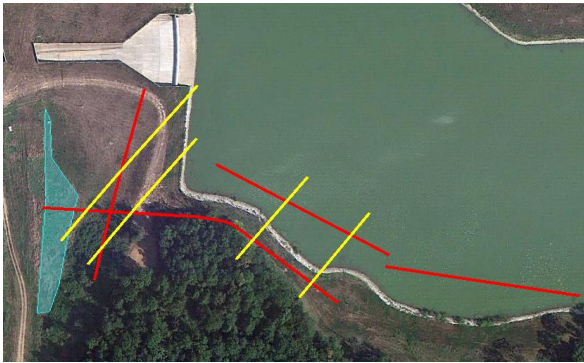
**Figure 8.** Interpreted solution-widened joint sets superposed on an aerial photograph of the study site (mark as yellow lines). ERT profile locations are marked as red lines. Lineaments orientation is southeast-northwest

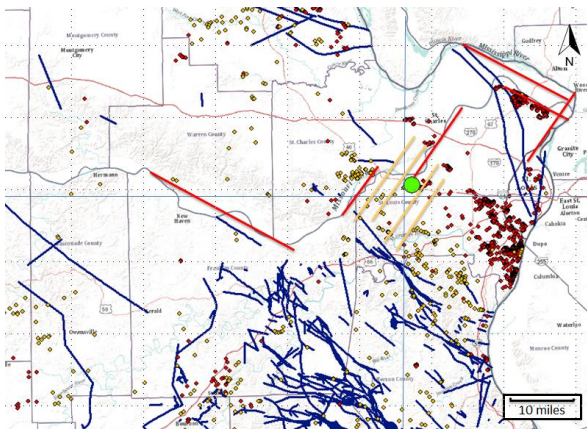
**Figure 9.** Interpreted solution-widened joints superposed (not to scale) on a map of known faults and structural lineaments in Missouri [Geoport]. Study site is marked as the green dot. Yellow lines trending southwest-northeast represent orientation of the interpreted lineaments. Red lines show orientation of major rivers in the study area
