### A Case Study on Usage of Electrical Resistivity Tomography for Dam Seepage Location, Chesterfield, Missouri

Four Electrical Resistivity Tomography (ERT) profiles and borehole data were acquired on the front face of the earth-filled dam and on the flanks, constituting Lake #1, in order to locate the seepage zone, the flow path, and to determine possible reasons of the seepage. The seepage, observed a year after the construction in the southwestern part of the lake, was severe and could cause further softening, slippage and erosion of soil, developing of pipe holes, increasing the water outflow and risk to the embankment integrity. The owner agreed to drain the lake in order to acquire geophysical and borehole data. Based on the analyses of the acquired ERT and borehole data, four solution-widened fracture zones trending from southwest to northeast were identified. It was concluded that the seepage pathway beneath the dam was through a solution-widened fracture zone, the top of which constituted the original stream channel.

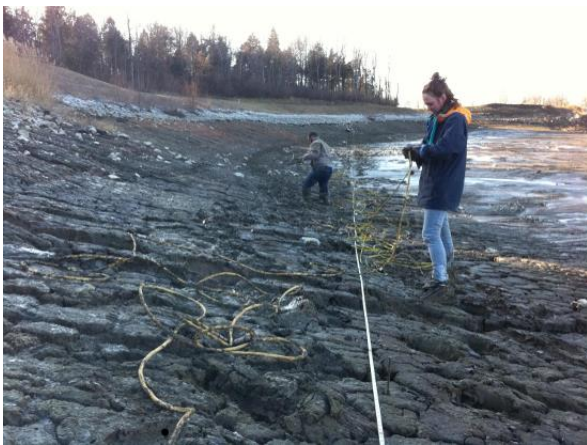
**Figure 6.** Photograph of the study site on the bottom of the lake (looking west,). ERT cables are set along Traverse C
